CENTRAL INTELLIGENCE AGENCY
Directorate of Intelligence
22 October 1963

INTELLIGENCE MEMORANDUM

SUBJECT: Interim Assessment of Hurricane Damage
in Cuba

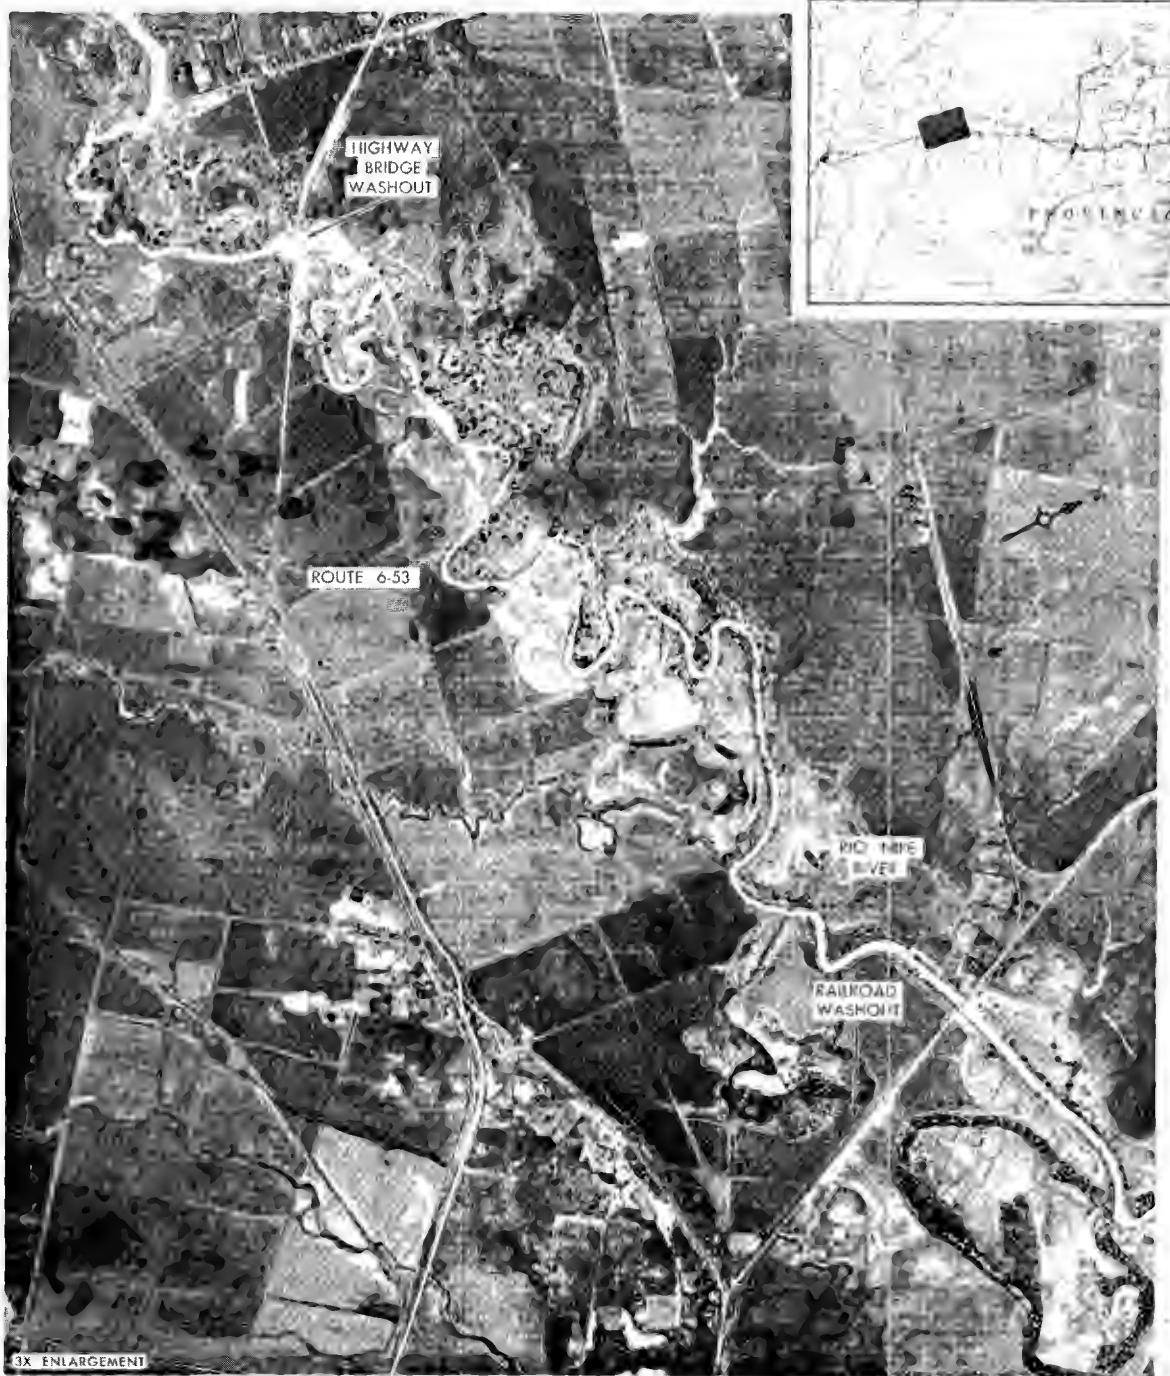
PHOTO #5 HIGHWAY BRIDGE WASHOUT

FLOOD DAMAGE WEST OF MAYARI
CUBA
20-40N 75-50W

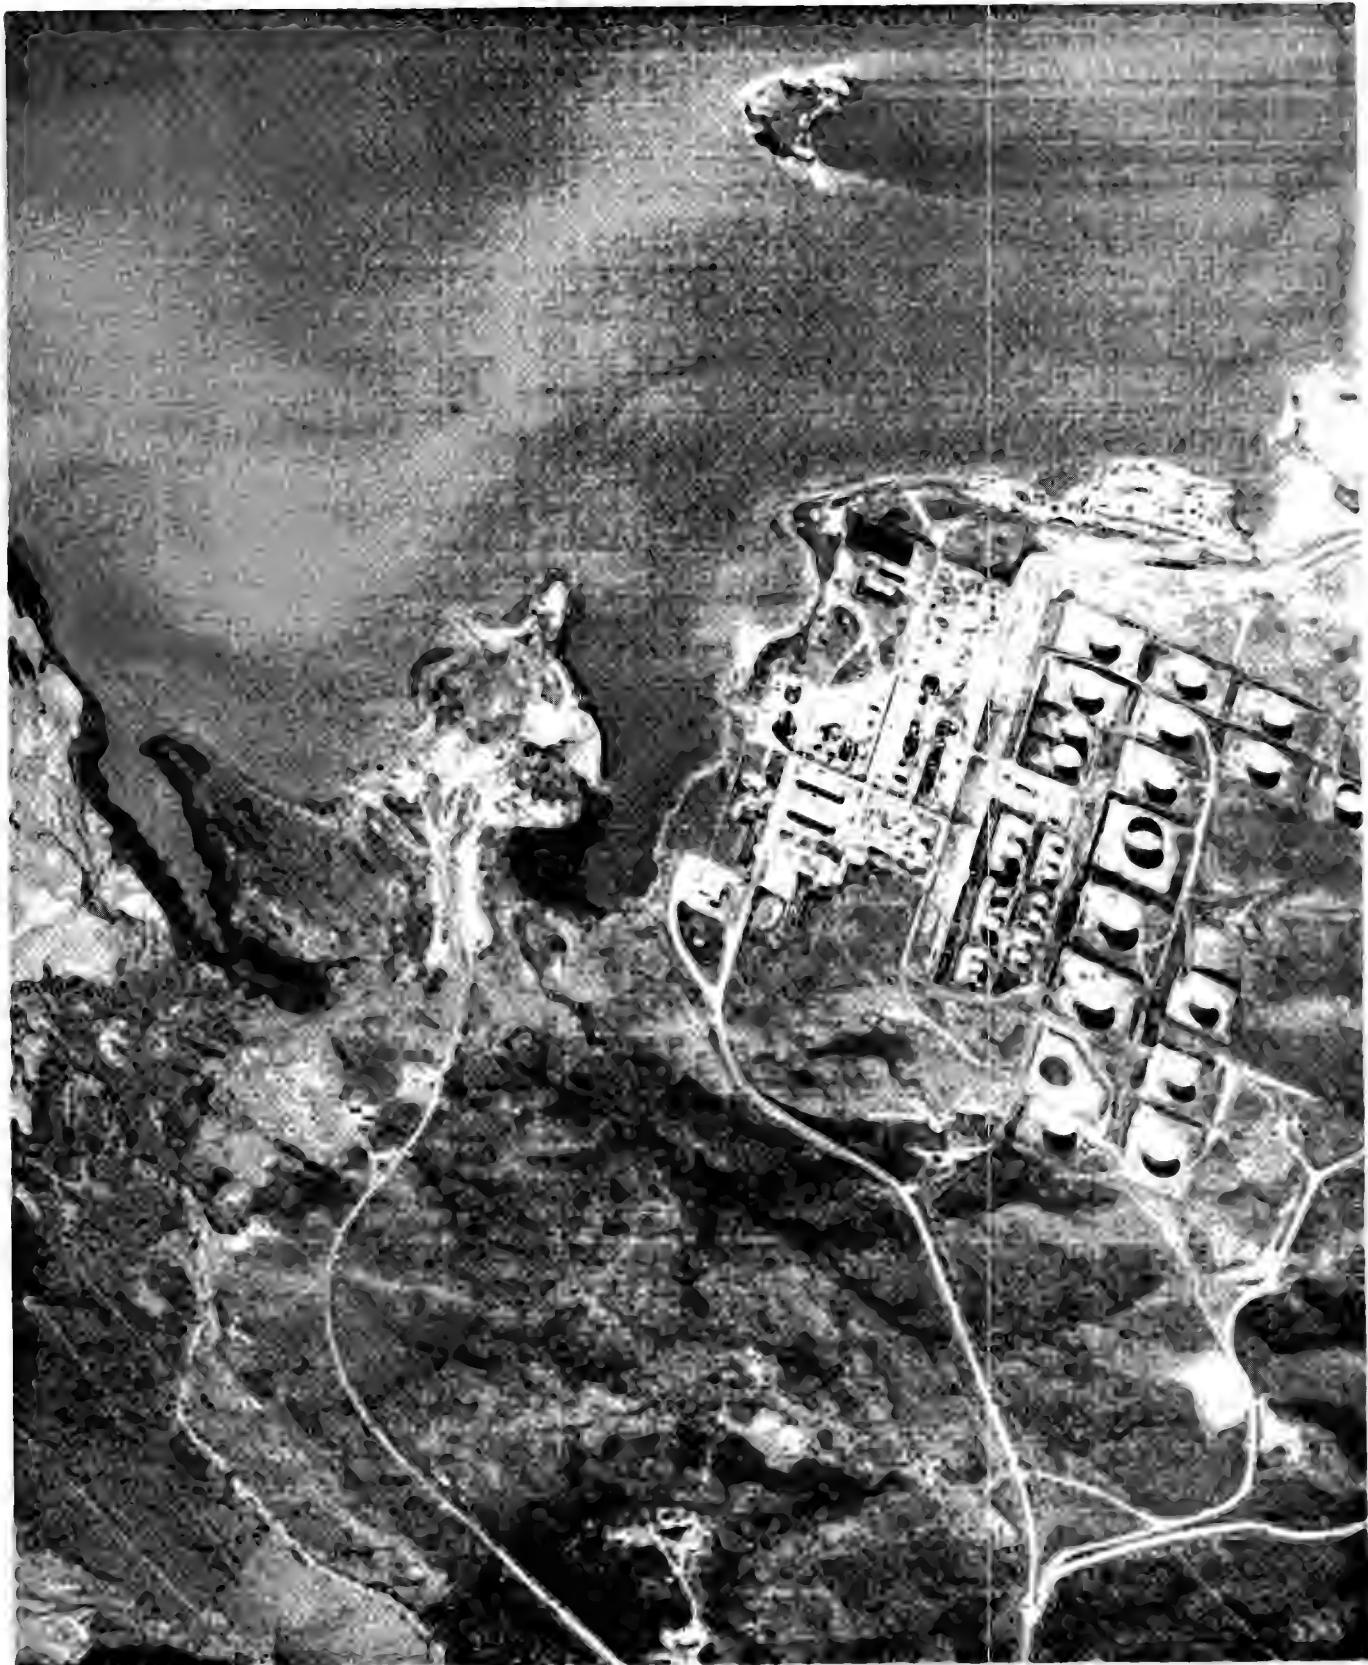
PHOTO #7

HERMANOS DIAZ PETROLEUM REFINERY, SANTIAGO DE CUBA
